Brookline Stone Arch Bridge Assessment Report and Repair Cost Guide

Prepared for: Stanley Noga Jr. Brookline Selectboard, Town of Brookline VT,

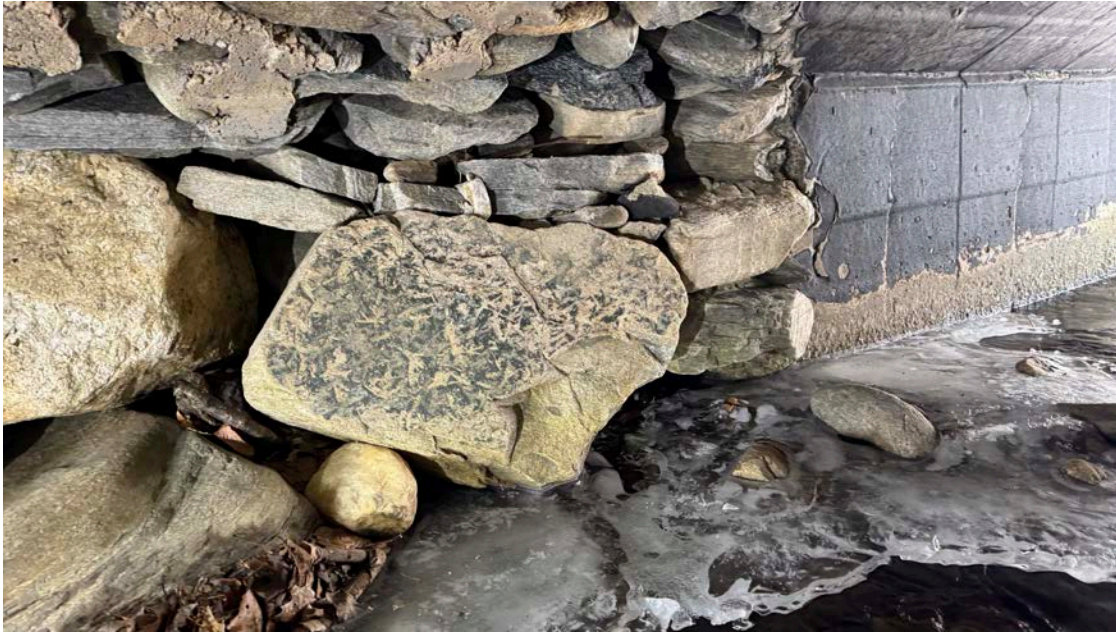
Above and below: Middle section of bridge south side. Large stone precariously balanced and holding the bridge above.

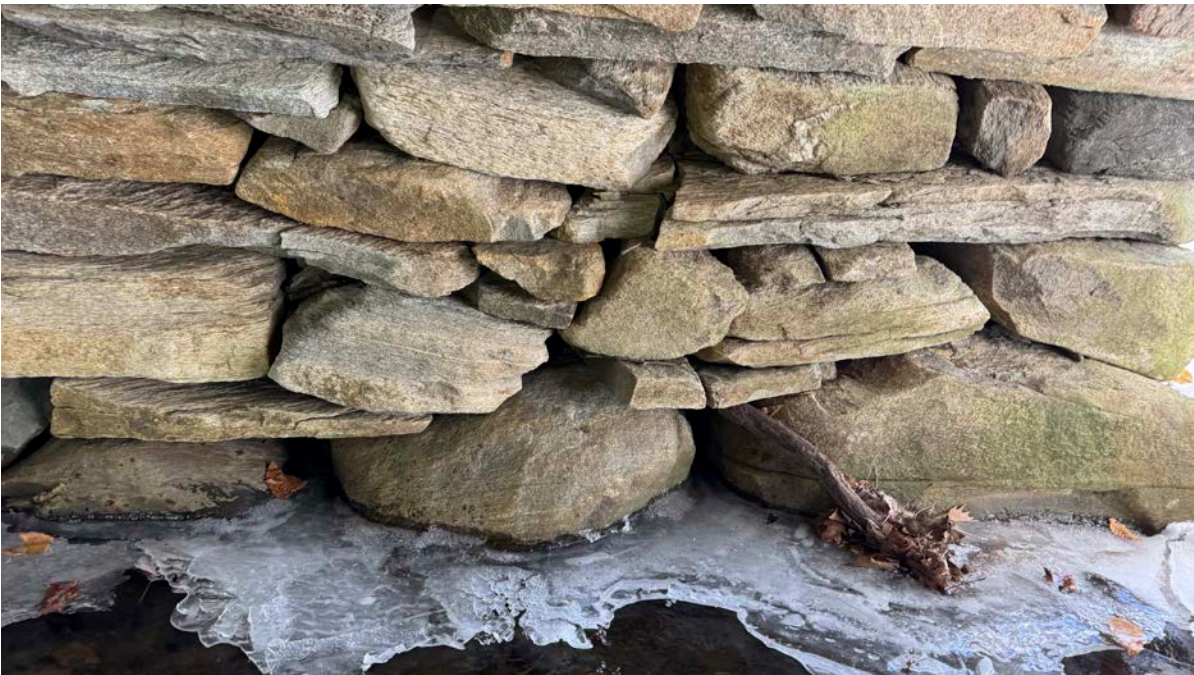
North side, downstream portion, shows some cracked stone and mortar loss, but is generally in good condition.

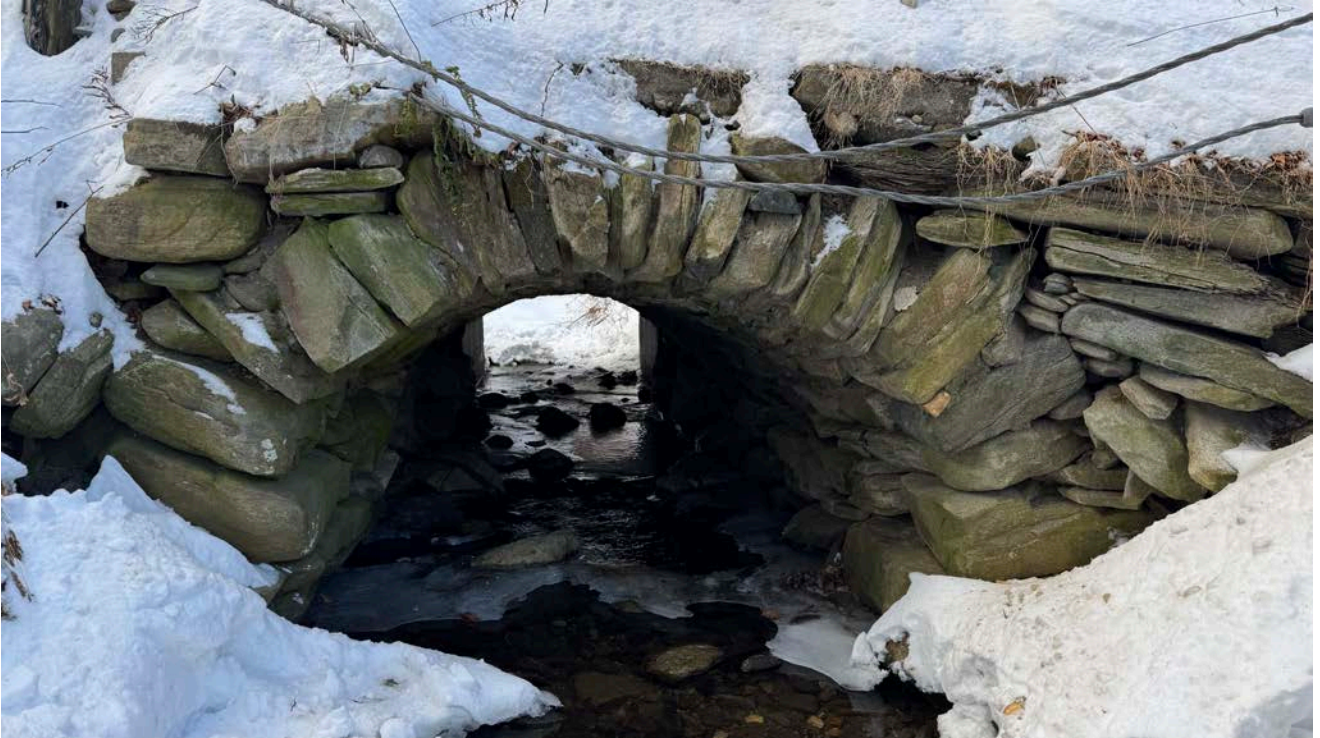
Downstream end. Note the stones on the south side (left) at the bottom of the arch appear to be sloped downward. This may indicate a problem with this section. Both wing walls are in poor condition.

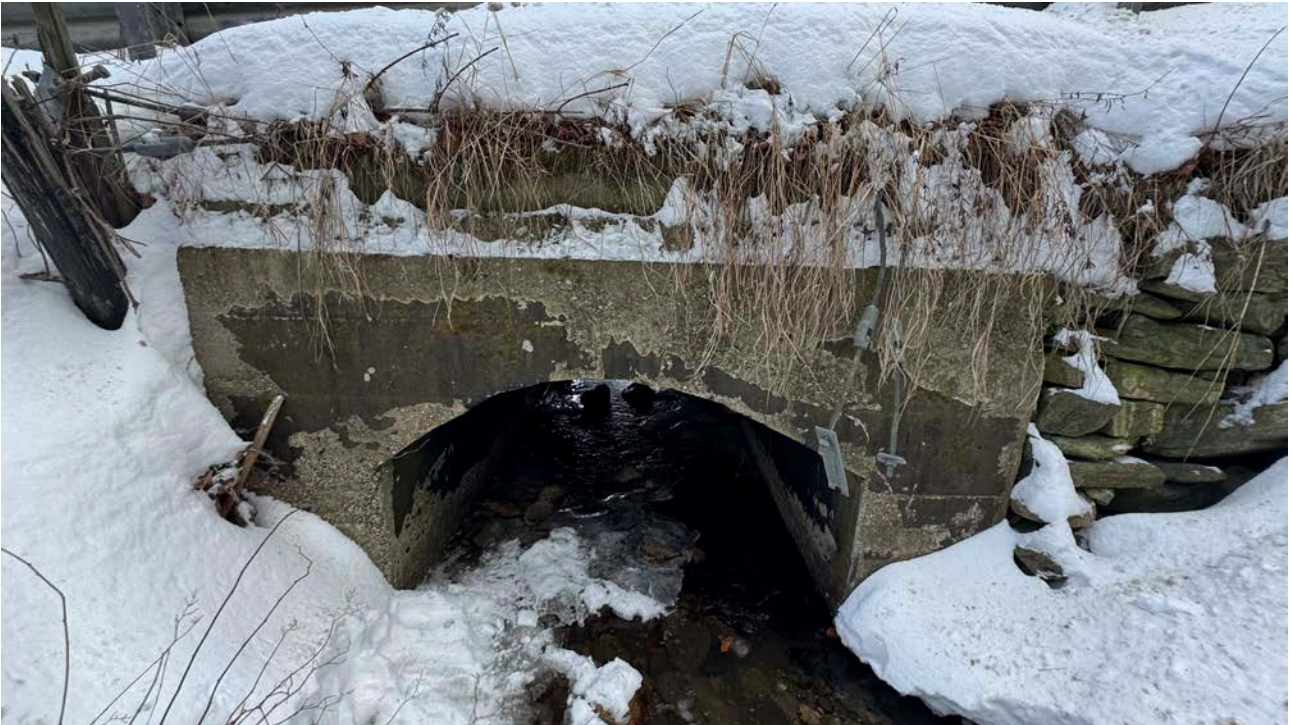
Upstream end. Concrete seems stable but the stone wing walls are deteriorating.
