Brookline Stone Arch Bridge Revised Assessment Report and Repair Cost Guide

Prepared for: Stanley Noga Jr. Brookline Selectboard, Town of Brookline VT,

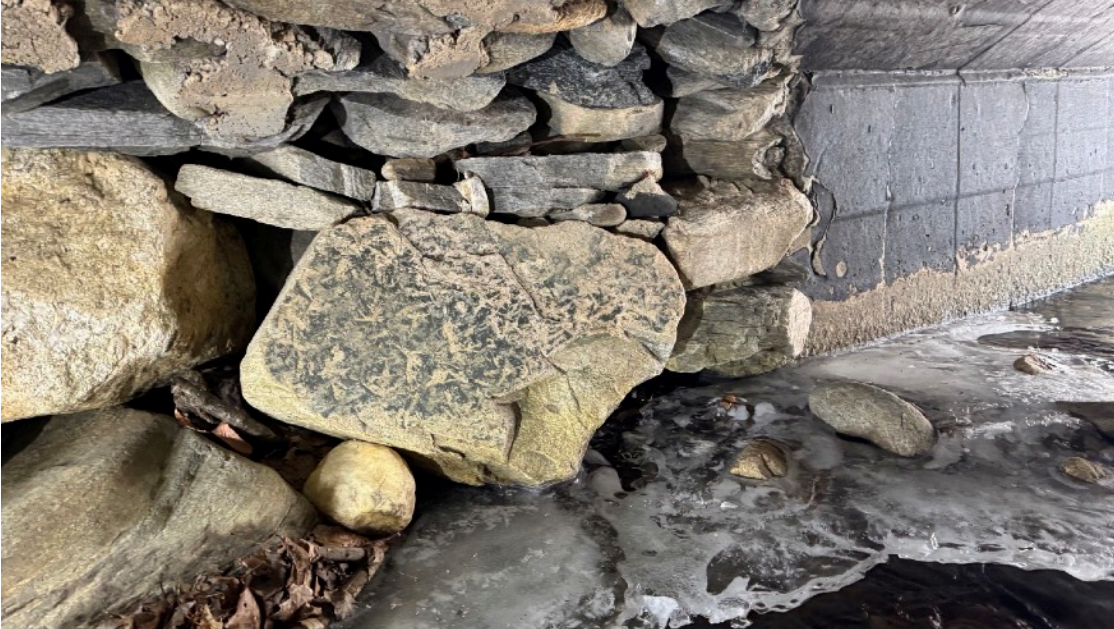
Above and below: Middle section of bridge south side. Large stone precariously balanced and holding the bridge above.

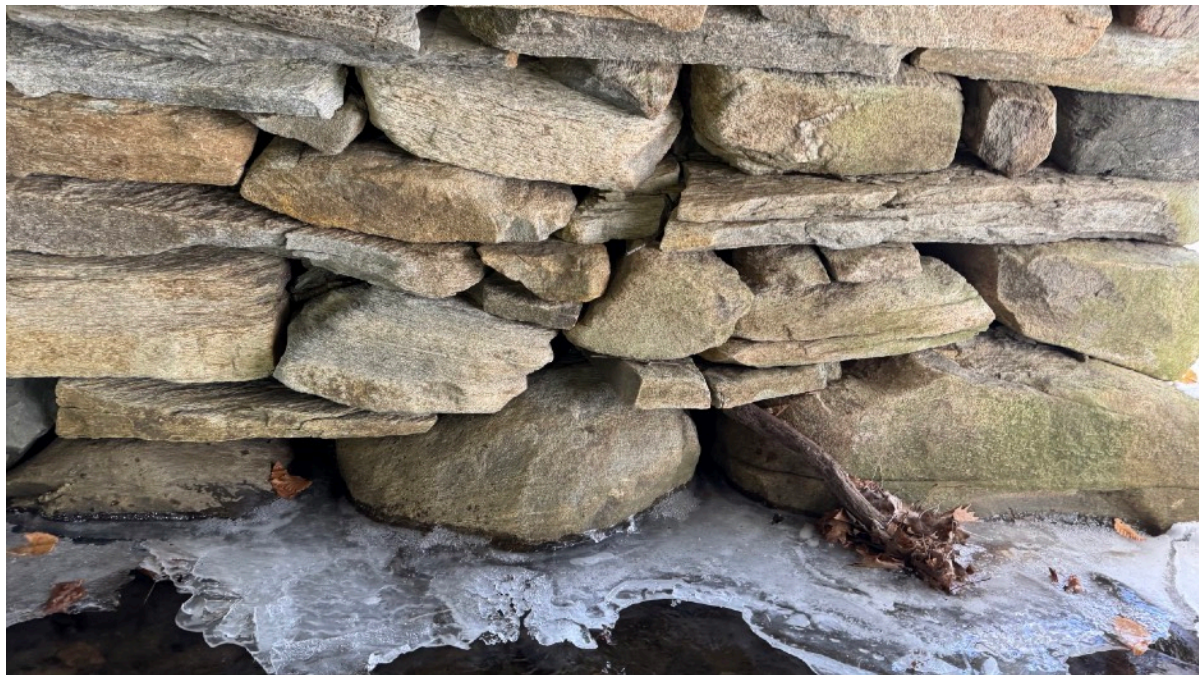
North side, downstream portion, shows some cracked stone and mortar loss, but is generally in good condition.

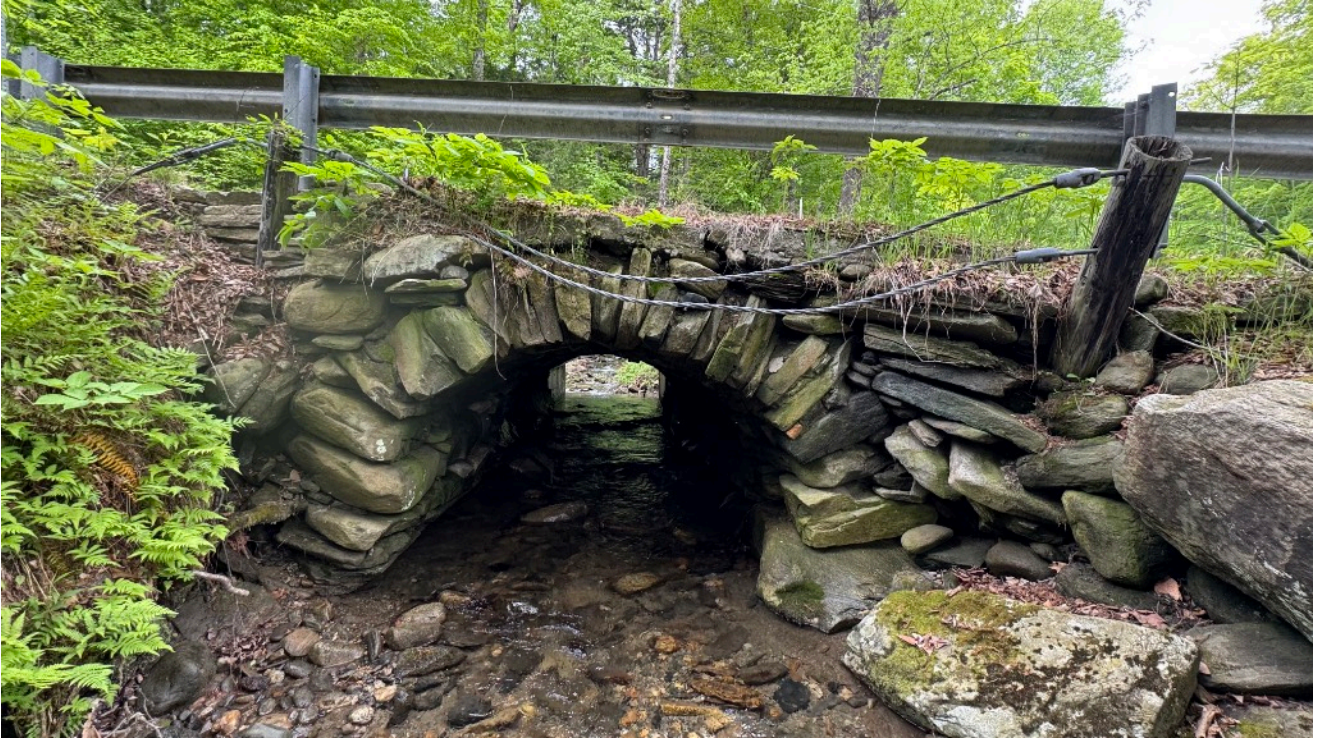
Downstream end. Note the stones on the south side (left) at the bottom of the arch appear to be sloped downward, but are in fact well supported and secure. The spandrel and wing walls are in very poor condition and need rebuilding.

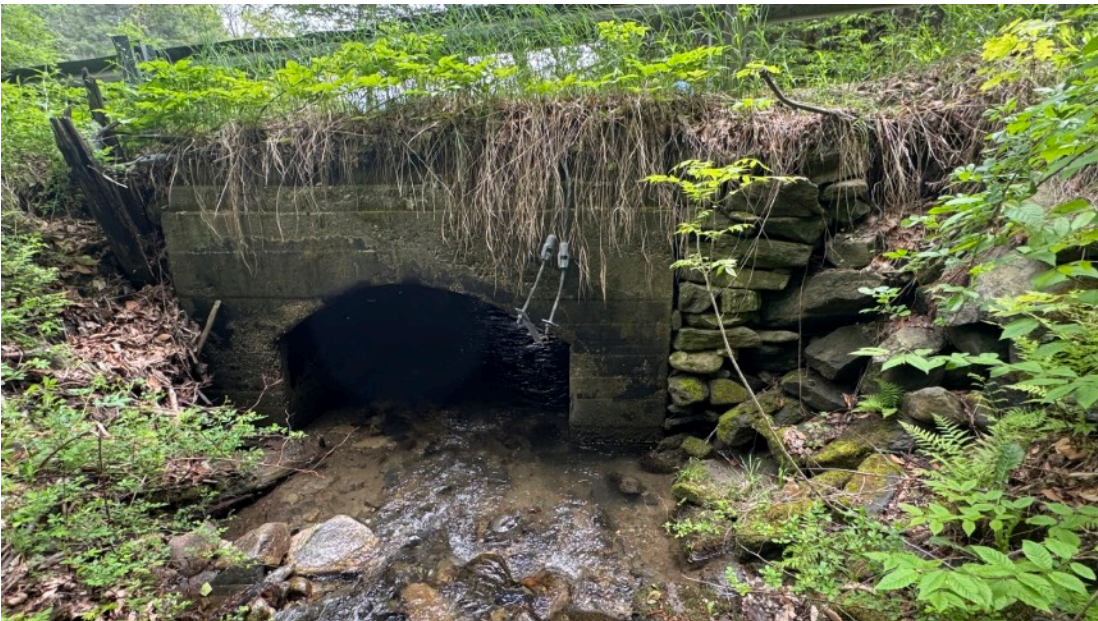
Upstream end. Concrete is stable but the stone wing walls are deteriorating, particularly the one to the south (right).
